# Zirconia-Toughened Alumina Insert Washers for Suspension Components: Coupled Tribocorrosion-Erosion Behavior in Road-Splash Media

Zhi Yang\*

College of Vehicle Engineering, Chongqing Industry Polytechnic University, Chongqing, 401120, China  
received February 14, 2026; received in revised form April 27, 2026; accepted May 24, 2026

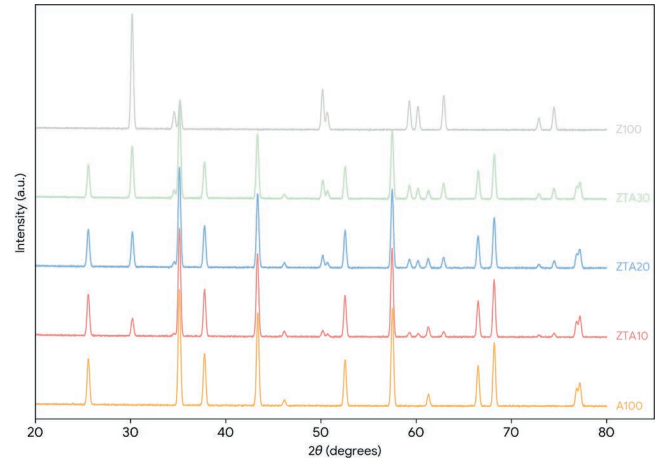
The XRD patterns of the as-sintered materials are presented in Fig. 1. The patterns confirm the expected phase compositions. The A100 pattern shows only peaks

corresponding to  $\alpha$ -Al<sub>2</sub>O<sub>3</sub> (corundum), and the Z100 pattern is dominated by peaks of the tetragonal ZrO<sub>2</sub> phase, indicating that the 3 mol% yttria was highly effective in stabilizing this metastable phase at room temperature. The patterns for ZTA10, ZTA20, and ZTA30 show a combination of peaks from both  $\alpha$ -Al<sub>2</sub>O<sub>3</sub> and t-ZrO<sub>2</sub>. Crucially, the intensity of peaks corresponding to the monoclinic ZrO<sub>2</sub> phase (e.g., near 28.2° and 31.5° 2 $\theta$ ) is negligible across all zirconia-containing samples, confirming that the processing and cooling steps did not induce premature transformation<sup>14</sup>.

Fig. 1: XRD patterns of the as-sintered ceramic materials.

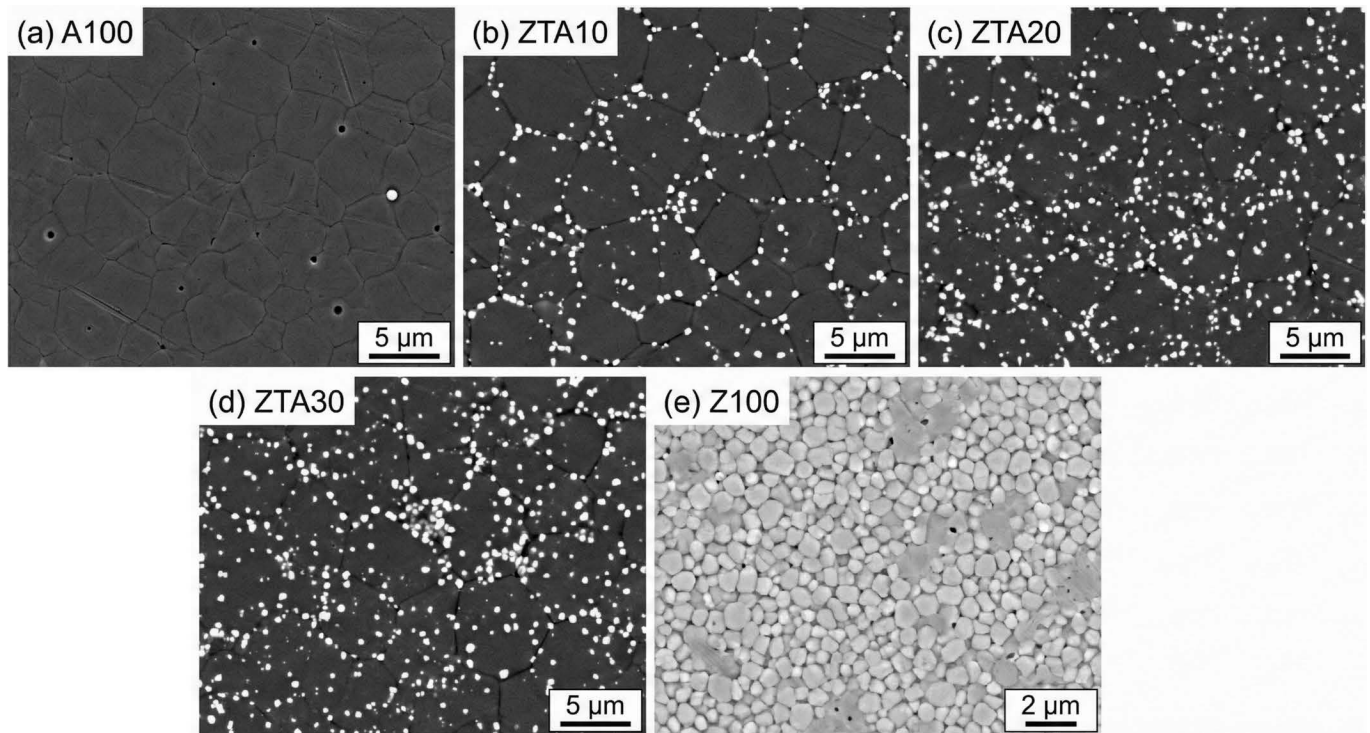
**Fig. 2:** BSE SEM micrographs of the as-sintered microstructures of (a) A100, (b) ZTA10, (c) ZTA20, (d) ZTA30, and (e) Z100.

Fig. 2 presents the backscattered electron SEM micrographs, which visually corroborate these findings. The monolithic A100 shows a dense, equiaxed grain structure. The fine-grained microstructure of monolithic Z100. The composite microstructures clearly show the bright 3Y-TZP particles (higher atomic number) homogeneously dispersed within the darker alumina matrix. The inter- and intragranular distribution of the zirconia particles is evident. This fine and uniform dispersion is essential for the effective operation of the transformation toughening mechanism, as it ensures that any propagating crack is likely to interact with the toughening phase<sup>29</sup>. The combination of high hardness from the continuous alumina matrix and high toughness imparted by the dispersed zirconia phase provides these ZTA composites with a balanced and superior set of initial mechanical properties compared to their monolithic constituents.

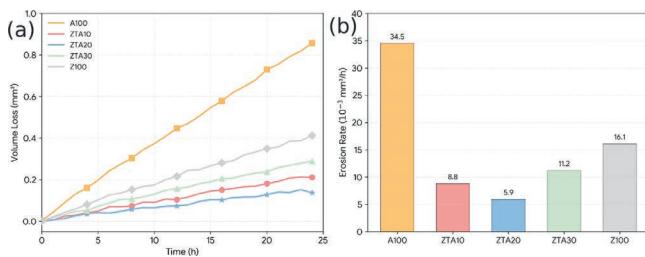
cumulative volume loss over the 24-hour test duration. The results, plotted in Fig. 3a, reveal distinct differences in the performance of the five ceramic materials. All samples exhibited an initial transient period of higher material loss, followed by a transition to a steady-state erosion rate, as indicated by the linear progression of volume loss over time.

The monolithic alumina, A100, demonstrated the poorest performance, suffering the highest total volume loss of 0.86 mm<sup>3</sup> after 24 hours. Its behavior is characteristic of a hard but brittle material under erosive attack. The impacting silica particles, although softer than alumina, possess sufficient kinetic energy to cause localized Hertzian contact stresses that exceed the fracture strength of the material, leading to the initiation and propagation of microcracks<sup>30</sup>. The dominant material removal mechanism is brittle fracture, involving lateral and radial cracking, which results in the detachment of entire grains or large fragments (grain pull-out), leading to a high rate of volume loss<sup>31</sup>.

In contrast, monolithic zirconia, Z100, showed significantly better resistance, with a total volume loss of 0.41 mm<sup>3</sup>, less than half that of A100. Despite its lower

hardness, Z100's substantially higher fracture toughness allows it to absorb more impact energy through plastic deformation and stress-induced phase transformation before fracture occurs<sup>32</sup>. This reduces the extent of cracking and shifts the material removal mechanism towards a more ductile mode involving ploughing and cutting, resulting in a lower material removal rate<sup>33,34</sup>.

The ZTA composites exhibited superior performance compared to both monolithic constituents. The volume loss for ZTA10, ZTA20, and ZTA30 was 0.22 mm<sup>3</sup>, 0.15 mm<sup>3</sup>, and 0.29 mm<sup>3</sup>, respectively. Notably, the ZTA20 composition displayed the lowest volume loss, achieving a nearly six-fold improvement in resistance compared to monolithic alumina and a 2.7-fold improvement over monolithic zirconia. This highlights the powerful synergistic effect of combining the two phases. The hard alumina matrix provides the primary resistance to indentation and abrasion from the slurry particles, while the finely dispersed zirconia particles act as a crucial defense against crack propagation. When a microcrack is initiated in the alumina matrix by an impact, its propagation is impeded as it encounters the high-stress compressive field generated by the t→m transformation of a nearby zirconia particle<sup>35</sup>. This mechanism effectively dissipates the impact energy, arrests crack growth, and prevents the large-scale brittle fracture observed in A100.

The steady-state erosion rates, calculated from the linear portion of the curves in Fig. 3a, are presented in the bar chart in Fig. 3b and summarized in Table 3. The trend mirrors the total volume loss, with ZTA20 exhibiting the lowest steady-state erosion rate of  $5.9 \times 10^{-3}$  mm<sup>3</sup>/h. The performance ranking is clear: ZTA20 > ZTA10 > ZTA30 > Z100 > A100. The fact that ZTA20 outperforms ZTA30 suggests that there is an optimal zirconia content. While increasing zirconia content enhances toughness, it simultaneously reduces hardness. The superior performance of ZTA20 indicates that it strikes the ideal balance between hardness (resisting initial particle penetration) and toughness (resisting subsequent crack propagation) for the specific conditions of this tribocorrosion-erosion test<sup>36</sup>.

**Fig. 3:** (a) Cumulative volume loss as a function of time for all five ceramic materials under slurry jet tribocorrosion-erosion testing. (b) Steady-state erosion rates calculated from the linear region of the volume loss curves. .

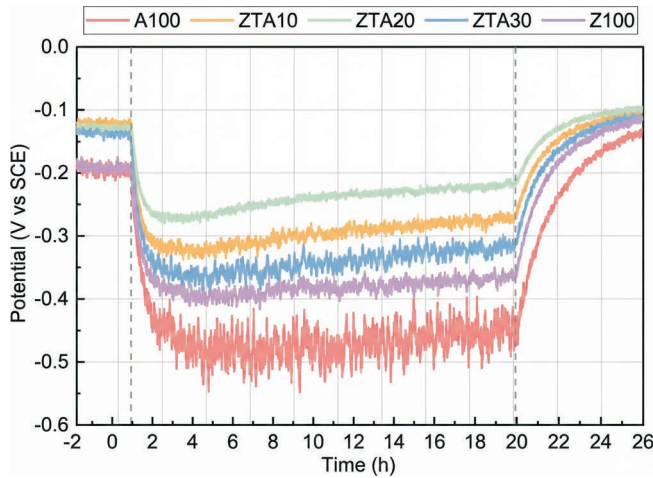
While ceramics are generally considered corrosion-resistant, the continuous mechanical damage from particle impingement can alter their surface chemistry and electrochemical response. Fig. 4 displays the evolution of the Open Circuit Potential (OCP) for each material before, during, and after the slurry jet impingement. Before the test ( $t < 0$ ), all samples exhibited a stable OCP, indicative of a passive surface in the NaCl solution. Upon initiation of the slurry jet (at  $t = 0$ ), a sharp and immediate drop in OCP was observed for all materials. This negative shift signifies a transition to a more active surface state, caused by the mechanical removal of any pre-existing passive layers and the generation of a fresh, damaged surface with high-density defects like microcracks and strained bonds, which are more electrochemically active<sup>37</sup>. Throughout the 24-hour test, the OCP remained at this lower, fluctuating potential. These oscillations are attributed to repeated depassivation and partial repassivation under particle impingement, with a likely additional contribution from flow pulsation associated with peristaltic pumping<sup>38,39</sup>. Accordingly, the OCP fluctuations are interpreted qualitatively as indicators of dynamic surface activation rather than as a purely stochastic signature of single-particle impacts. After the slurry jet was stopped ( $t > 24$  h), the OCP began to slowly drift back towards more positive values, indicating a gradual repassivation or stabilization of the damaged surface. The magnitude of the initial OCP drop was most pronounced for A100, followed by Z100, and was least significant for the ZTA composites, particularly ZTA20. This suggests that the ZTA20 surface is more resilient to mechanical depassivation, aligning with its superior material loss performance.

**Fig. 4:** OCP evolution versus time for the ceramic samples in 3.5 % NaCl slurry.

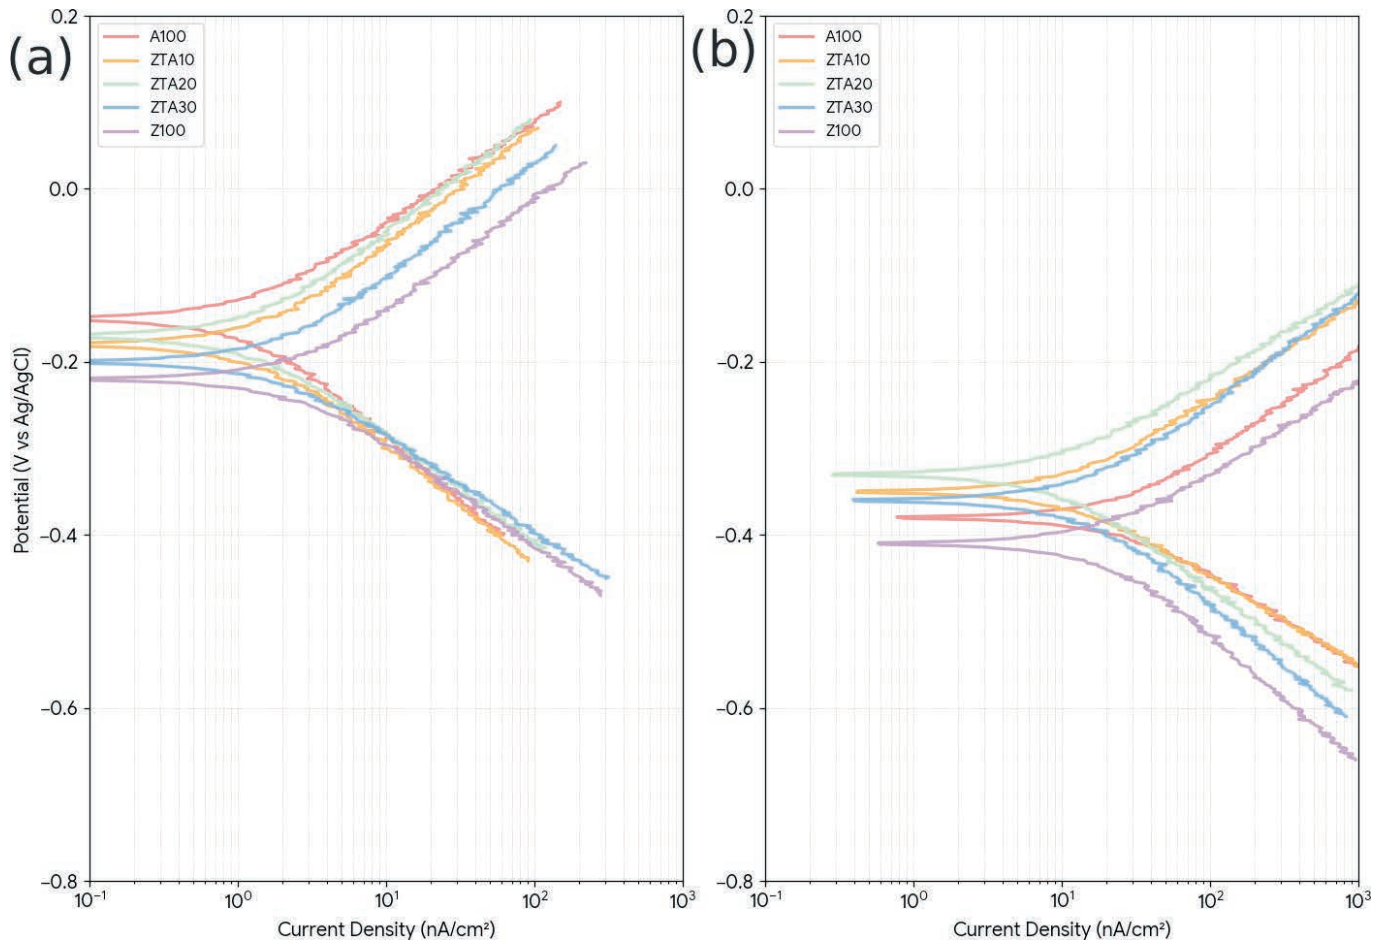
The potentiodynamic polarization curves, shown in Fig. 5, provide quantitative insights into the corrosion behavior. Before erosion (Fig. 5a), all materials displayed very low corrosion current densities ( $i_{\text{corr}}$ ), characteristic of highly passive materials. After 24 hours of tribocorrosion-erosion (Fig. 5b), the polarization curves for all samples shifted towards higher current densities, confirming that the mechanical damage increased their electrochemical activity. The extracted corrosion parameters are listed in Table 4. While the absolute  $i_{\text{corr}}$  values remain low compared to metals, the relative changes are significant. A100 showed the largest increase in  $i_{\text{corr}}$ ,

consistent with its extensive surface damage. The ZTA composites, especially ZTA20, maintained the lowest  $i_{\text{corr}}$  values after the test, indicating a greater ability to resist electrochemical degradation even in a mechanically damaged state.

**Fig. 5:** Potentiodynamic polarization curves for the ceramic materials in 3.5 % NaCl solution (a) before and (b) after 24 hours of tribocorrosion-erosion testing.

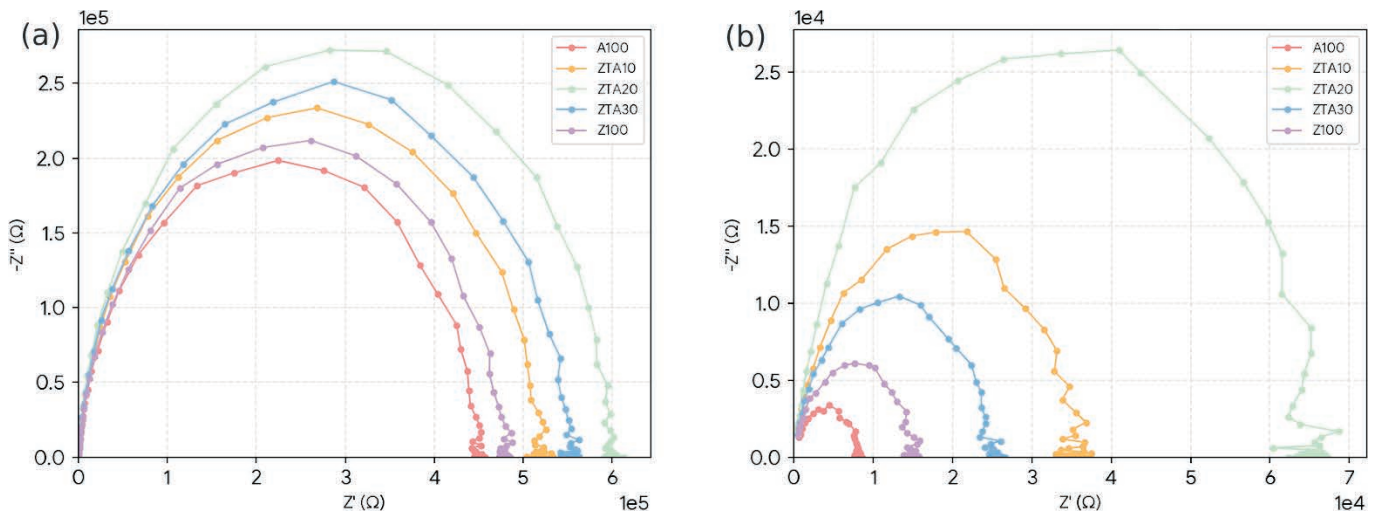
Further analysis was conducted using Electrochemical Impedance Spectroscopy (EIS). The Nyquist plots in

Fig. 6 show the impedance response before and after the test. Before testing (Fig. 6a), all materials exhibit very large, semi-circular arcs, indicative of a high apparent polarization resistance and a highly capacitive surface. For ceramic-electrolyte interfaces, however, the semicircle diameter can reflect combined contributions from interfacial charge transfer, defect or pore pathways, and non-ideal capacitive behavior; therefore it is discussed here as an overall interfacial impedance response rather than as a rigorously isolated charge-transfer resistance<sup>40</sup>. After 24 hours of tribocorrosion-erosion (Fig. 6b), the diameters of the semicircles for all materials decreased dramatically, signifying a substantial reduction in apparent polarization resistance. This confirms that the erosion damage severely compromised the protective nature of the ceramic surfaces, creating easier pathways for interfacial electrochemical reactions. Consistent with all other data, the post-test Nyquist plot for ZTA20 retained the largest diameter, confirming it maintained the most corrosion-resistant surface among the tested materials. The electrochemical results, while secondary to the massive material loss from mechanical erosion, consistently support the performance ranking derived from the volume loss data and demonstrate that the ZTA composites, particularly ZTA20, possess a superior ability to withstand the coupled chemical-mechanical attack.

**Fig. 6:** Nyquist plots from EIS measurements for all materials (a) before and (b) after 24 hours of tribocorrosion-erosion testing.

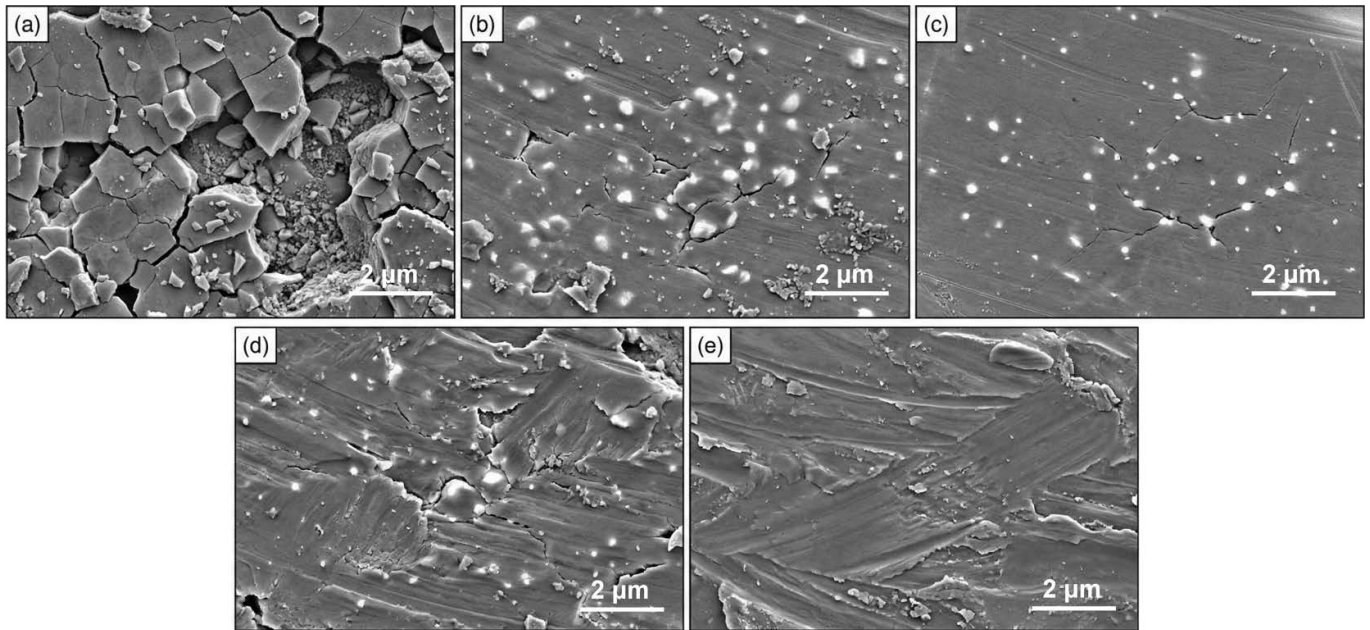
To elucidate the physical mechanisms responsible for the observed differences in performance, the wear scars were meticulously examined using SEM and 3D profilometry. The SEM micrographs in Fig. 7 provide compelling visual evidence of the distinct degradation modes for each material. The surface of A100 is characterized by extensive brittle fracture. Widespread intergranular cracking is visible, and numerous locations show evidence of entire grains having been dislodged (grain pull-out), leaving deep cavities. This mode of material removal is inefficient in terms of energy absorption and leads to rapid surface degradation and the high volume loss observed.

The wear scar on Z100 presents a different morphology. While some micro-cracking is present, the surface also exhibits shallow ploughing grooves and microcutting features created by the scraping action of the silica particles. This behavior is consistent not only with the higher toughness of zirconia, but also with the relatively small hardness contrast between Z100 (13.1 GPa) and silica erodent particles (typically about 10–12 GPa), a regime in which brittle-material erosion is less dominated by catastrophic lateral cracking and more influenced by mixed ploughing and crushing processes<sup>36,41</sup>. Consequently, Z100 can absorb a larger fraction of impact energy before fragment detachment occurs, resulting in lower material loss than alumina.

The ZTA composites display a hybrid degradation mechanism that leverages the strengths of both constituents. The wear scar on the best-performing

ZTA20 sample is remarkably smoother than that of A100. While some ploughing is visible on the alumina grains, the most significant feature is the absence of large-scale grain pull-out. High-magnification images reveal microcracks that have been arrested or deflected upon intersecting with the zirconia particles. This crack interaction is the macroscopic manifestation of the transformation toughening mechanism at work, preventing small-scale damage from coalescing into catastrophic material removal<sup>45</sup>. The degradation appears to be a more controlled, layer-by-layer removal process rather than the wholesale ejection of material seen in A100. The surfaces of ZTA10 and ZTA30 show slightly more damage than ZTA20, consistent with their intermediate volume loss performance.

Fig. 7: SEM micrographs of (a) A100, (b) ZTA10, (c) ZTA20, (d) ZTA30, (e) Z100 after 24 hours of tribocorrosion-erosion testing.

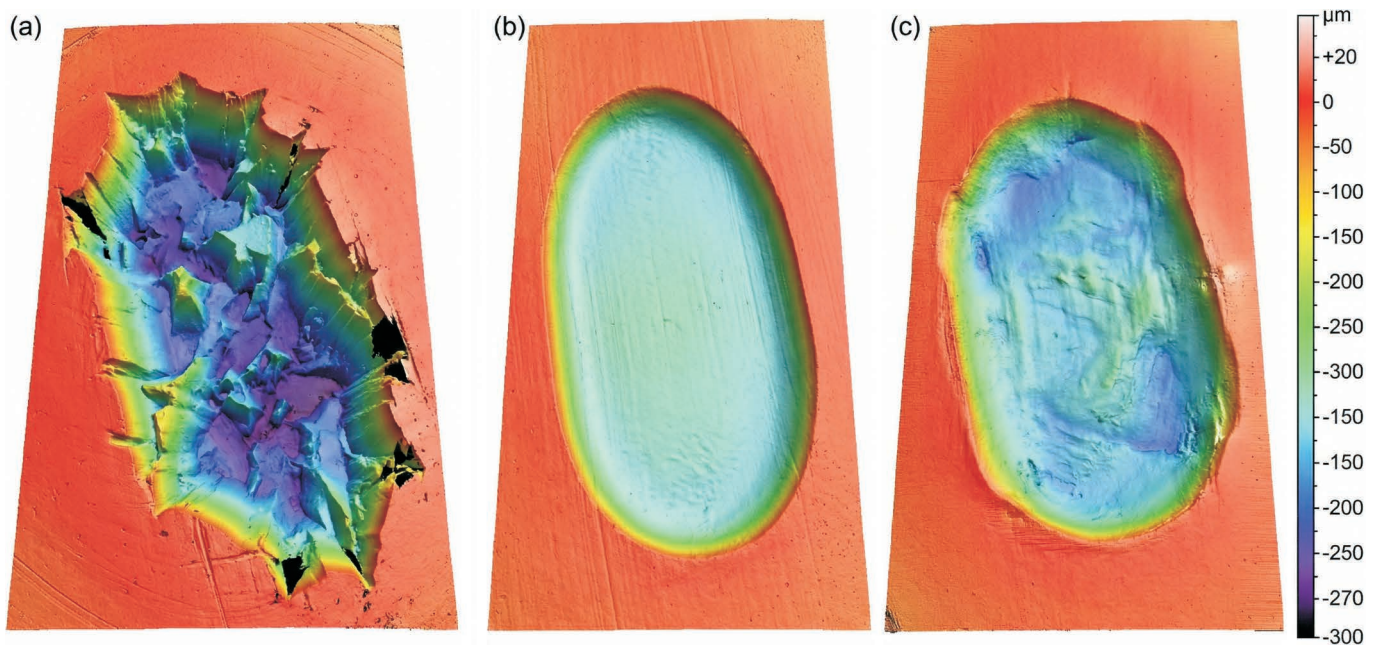
The 3D optical profilometry images in Fig. 8 provide a quantitative, macroscopic view of the wear scars. The images visually confirm the severity of material loss, with the A100 sample exhibiting the deepest and widest wear crater. The ZTA20 crater is clearly the most shallow and narrow, corroborating the gravimetric data. The surface roughness ( $R_a$ ) within the wear scar was also measured (Table 4). The heavily damaged A100 surface was the roughest (1.85  $\mu\text{m}$ ), while the ZTA20 surface was the smoothest (0.45  $\mu\text{m}$ ). The smoother surface of ZTA20 is advantageous as it presents fewer stress-concentrating features for subsequent particle impacts, contributing to its lower steady-state erosion rate.

Fig. 8: 3D optical profilometry images of the wear craters on the surfaces of (a) A100, (b) ZTA20, and (c) Z100 after 24 hours of testing.

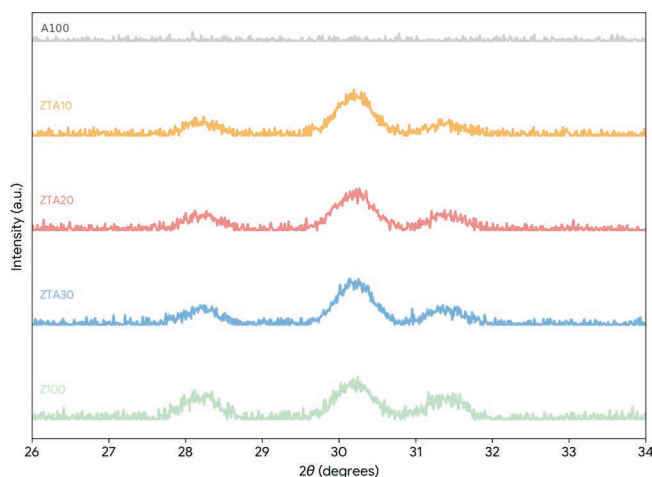
The definitive evidence of the active toughening mechanism is provided by the XRD analysis of the wear scars, shown in Fig. 9. Compared to the as-sintered patterns, the XRD patterns from the worn surfaces of Z100, ZTA10, ZTA20, and ZTA30 show the distinct emergence and growth of peaks corresponding to the monoclinic zirconia ( $m\text{-ZrO}_2$ ) phase. This is direct evidence of the stress-induced martensitic transformation from  $t\text{-ZrO}_2$  to  $m\text{-ZrO}_2$  occurring in response to the high stresses generated by the particle impacts<sup>46</sup>. Quantitative Rietveld analysis, centered on the wear-scar region, indicated that the monoclinic phase fraction within the damaged zone of the ZTA20 sample increased from  $<0.1\%$  to approximately  $45\%$ . The ZTA10 and ZTA30 samples showed corresponding localized trans-

formed fractions of about  $38\%$  and  $42\%$ , respectively, while the Z100 sample reached about  $55\%$ . Because the finite X-ray footprint can partly average the crater with adjacent unworn surface, these values should be interpreted as semiquantitative wear-zone estimates rather than perfectly crater-confined absolute phase fractions. The substantial transformation in the ZTA samples confirms that this energy-dissipating mechanism was highly active and is the primary reason for their enhanced toughness and superior erosion resistance. The fact that Z100 transformed more but performed worse than the ZTA composites suggests that the toughening mechanism alone is not sufficient; it must be paired with the high hardness of the alumina matrix to achieve optimal performance against abrasive and erosive wear.

Fig. 9: XRD patterns taken from within the wear scars after 24 hours of tribocorrosion-erosion testing.
